OPERATING EXPERIENCE WEEKLY SUMMARY

Office of Nuclear and Facility Safety

August 7 - August 13, 1998

Summary 98-32

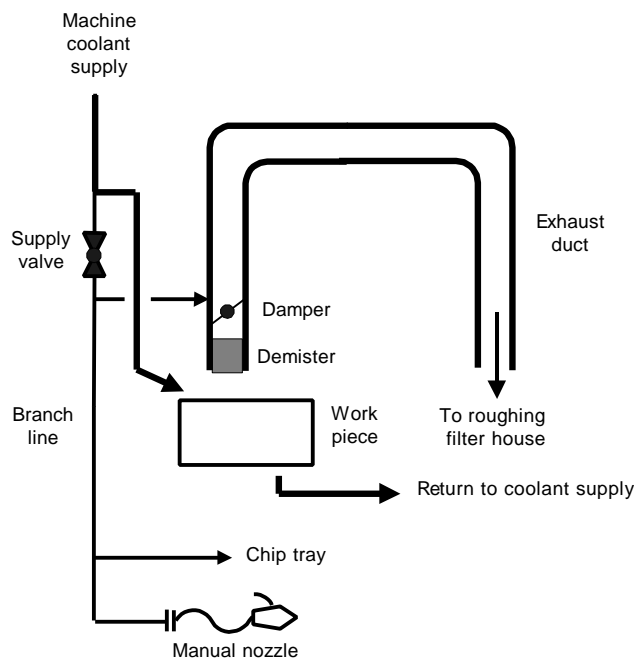
Figure 2-1. Configuration of Machine Coolant and Process Exhaust Systems

Investigators reported that a machine coolant system supplies water-based coolant containing borax to several facility machines to remove heat generated during uranium metal forming (Figure 2-1). At each machine, a branch line from a main supply line directs machine coolant through a normally closed, lever-actuated ball valve when it is needed to quench excessive heat or fire in either a room exhaust line or a chip tray. A third connection supplies a hand-held, normally closed spray nozzle. A process exhaust system draws machine room air directly over the work piece to minimize the spread of contaminants. The exhaust duct rises approximately 3 feet, runs horizontally, and drops vertically to the roughing filter house, which is maintained at low pressure by exhaust fans. The machine coolant connection penetrates the exhaust duct above a demister and a normally open damper.

Investigators determined that the manual coolant supply valve was approximately half open and that the connection to the chip tray was completely clogged with crystallized borax. The connection to the exhaust duct presented the only open pathway for coolant loss, and investigators believe the atmospheric flow rate in the duct was high enough to transfer 120 gallons over a work shift. The machine operator told investigators that he might have bumped the valve handle. Investigators located the missing coolant on the floor of the roughing filter house, where negative pressure maintained by the process exhaust system prevented leakage past the access door. Facility engineers determined that the transfer of machine coolant to the roughing filter house did not compromise the criticality safety double-contingency principle. They also determined that neither the inadvertent transfer of coolant nor its return to the storage tanks constituted an unreviewed safety question. Short-term corrective actions included pumping the coolant back to the coolant storage tanks and increasing the frequency of surveillance of coolant storage tank level. Investigators reported that a recent change from coolant with a flammable component to water-based coolant has eliminated the need for connections to the machine room exhaust ducts. Long-term corrective actions include removing and blanking these connections.

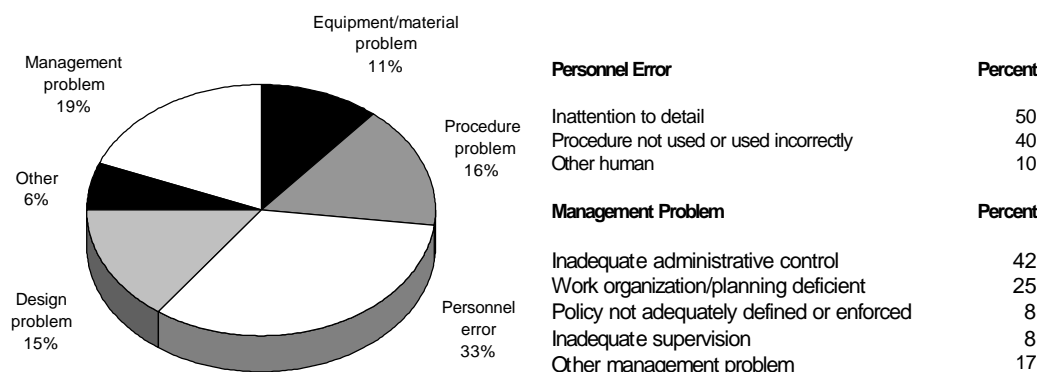
Figure 2-2. Distribution of Root Causes for Inadvertent Transfer of Solutions¹

OEAF engineers reviewed the complete ORPS database for reports involving inadvertent transfers of solutions and selected 62 occurrences. Figure 2-2 shows the distribution of root causes reported by facility managers for these events. Personnel error represented 33 percent of the root causes, and management problems represented 19 percent. Inattention to detail accounted for 50 percent of the personnel errors, and inadequate administrative control accounted for 42 percent of the management problems.
